THE EFFECTS OF URIC SALTS ON OTHER NON-WATER URINALS

Case Study: McDonald's Restaurant- Nerang, Gold Coast Queensland

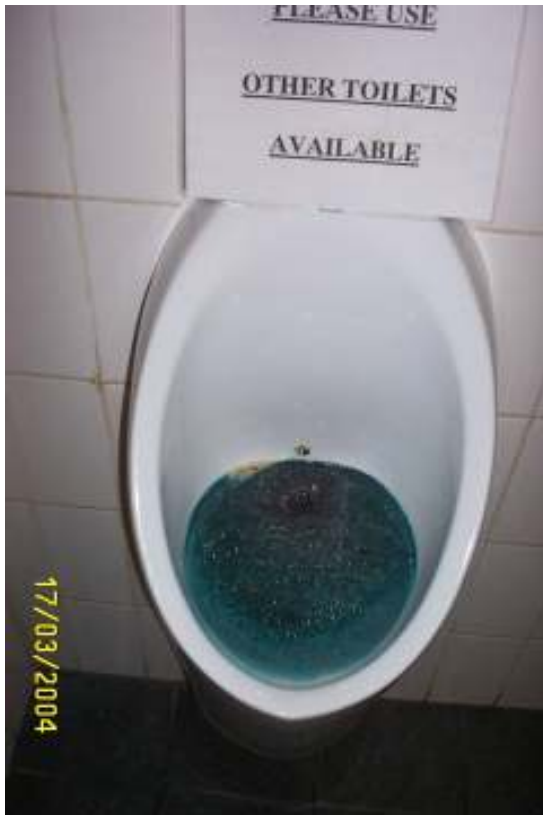
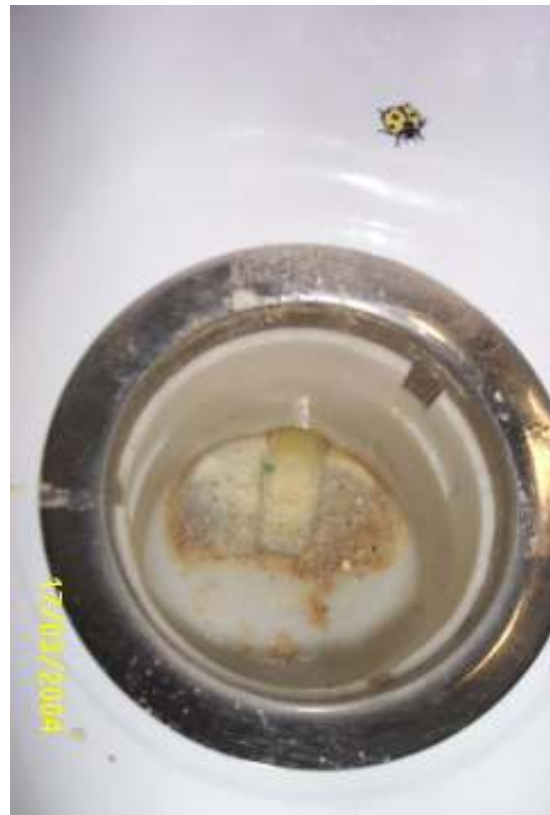
The above photographs show one of three urinals that have been installed in a major shopping centre on the Gold Coast. This urinal uses a non-reusable cartridge which is locked into place and has a capacity of less than 0.5 litres. The right hand picture shows how the salts have been forced through the cartridge and into the body of the housing, effectively blocking the outlet of the fixture. These salts also deposit heavily in the main drains causing blockages which require cleaning with a high pressure water jetrodder.

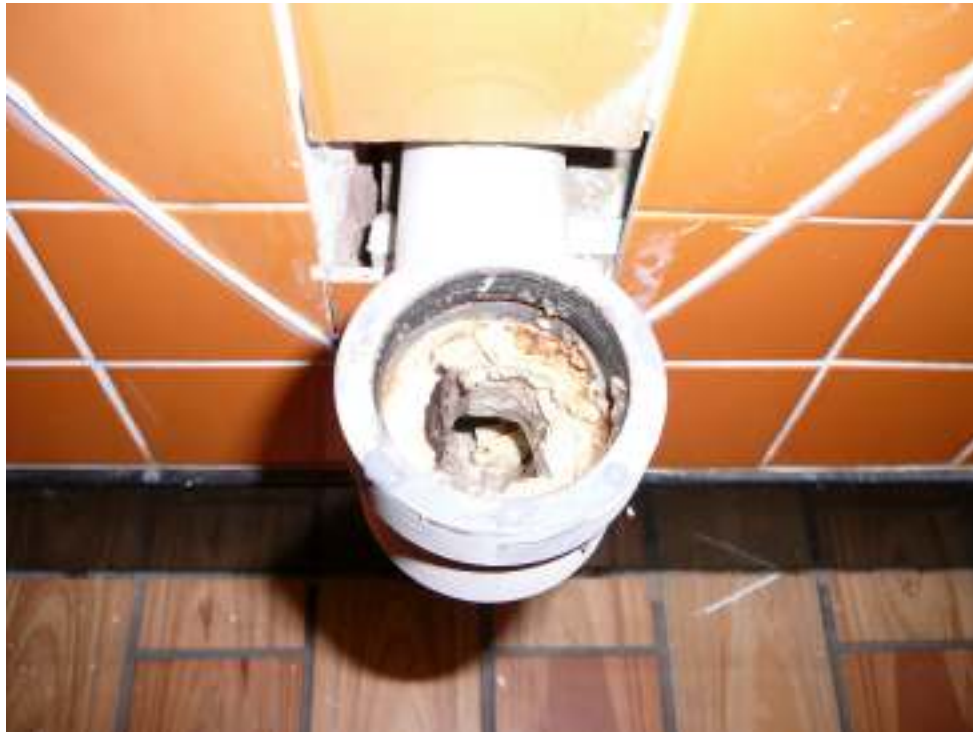
Background: This restaurant on average sees over six thousand five hundred customers pass through its doors every day, and during peak holiday periods, almost ten thousand people. The store had two water flushing urinals installed on the premises, which were converted to Uridan brand water-free urinals. These urinals were installed in position for over one year and had the main drains cleaned on three separate occasions.

Six months after the final drain cleaning procedure, the urinals were removed for installation of two ZeroFlush model ZF-201 urinals. The technicians on site were amazed to find the amount of build up in the drains as demonstrated in the picture below.

The Solution: After the Uridan urinals had been removed, high pressure cleaning of the drains was again performed to remove the *massive* build up of uric salts. With the drainage system in now optimal condition, the new ZeroFlush urinals were installed into position and commissioned for immediate use.

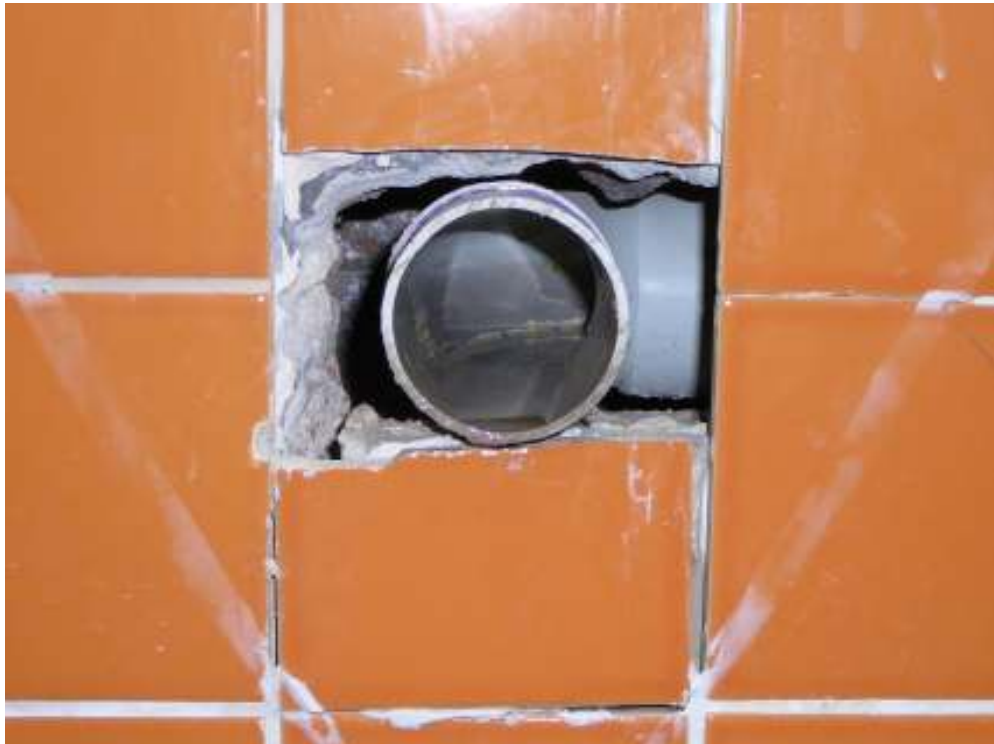
The Test: Exactly six months after the installation of the ZeroFlush urinals, one of our technicians returned to remove the adult urinal which receives more than three times the use as the junior fixture.

To perform the test, our technician simply removed the trap insert and poured down a bucket of water, the same as any normal maintenance. This removes the uric sludge from the housing and flushes it through into the sewer main where it relies on the water from other fixtures to move it out of the premises. No chemicals or pressure machines were used to clean the pipes beforehand.

The urinal was removed from position by simply cutting the silicone seal around the outside of the fixture and then disconnecting the rubber Fernco which connects the housing outlet to the fixture discharge pipe. A photograph was taken immediately after this and the results speak for themselves.
